A Review of the Temporary Shoring Used to Stabilize the Pentagon After the Terrorist Attacks of September 11th, 2001

A Final Scholarly Paper

Leo J. Titus, Jr., P.E.

May 3, 2002

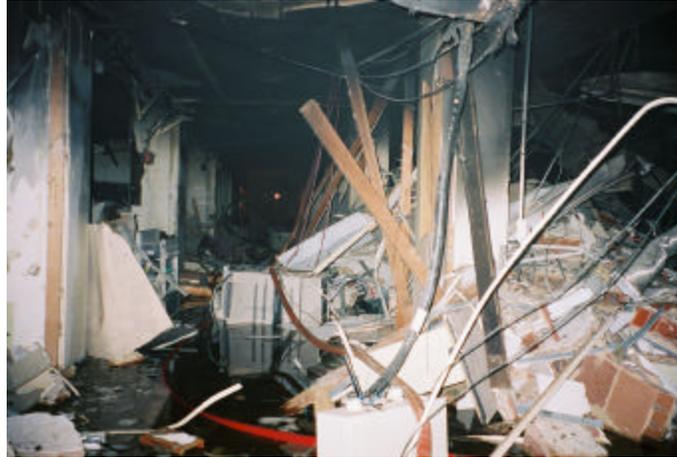
As the reconnaissance teams entered the building, the magnitude of the destruction was realized. The debris from the impact and explosion extended from the floor to the ceiling. This made maneuvering very difficult as the team attempted to move through the building. Figures 6 and 7 are pictures taken on the first floor of the Pentagon in the first days after the attack. They illustrate the obstacles that the recon teams were faced with. Other conditions which made the reconnaissance even more difficult were the intense heat, smoke and scalding water falling from the fire suppression activities on the upper floors.

Figure 6. First floor interior damage.

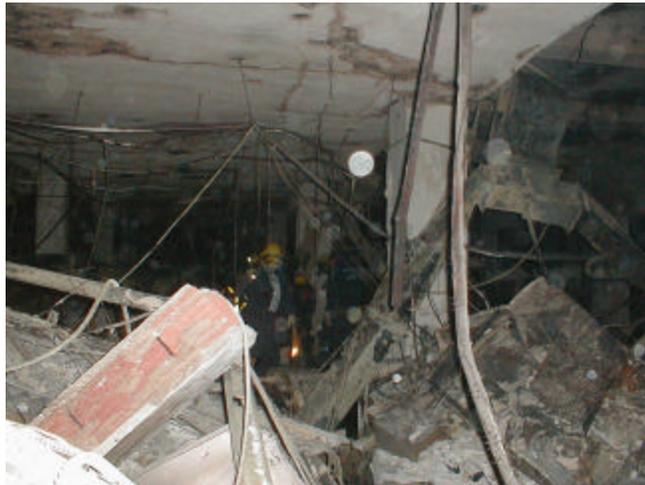
Figure 7. First floor interior damage

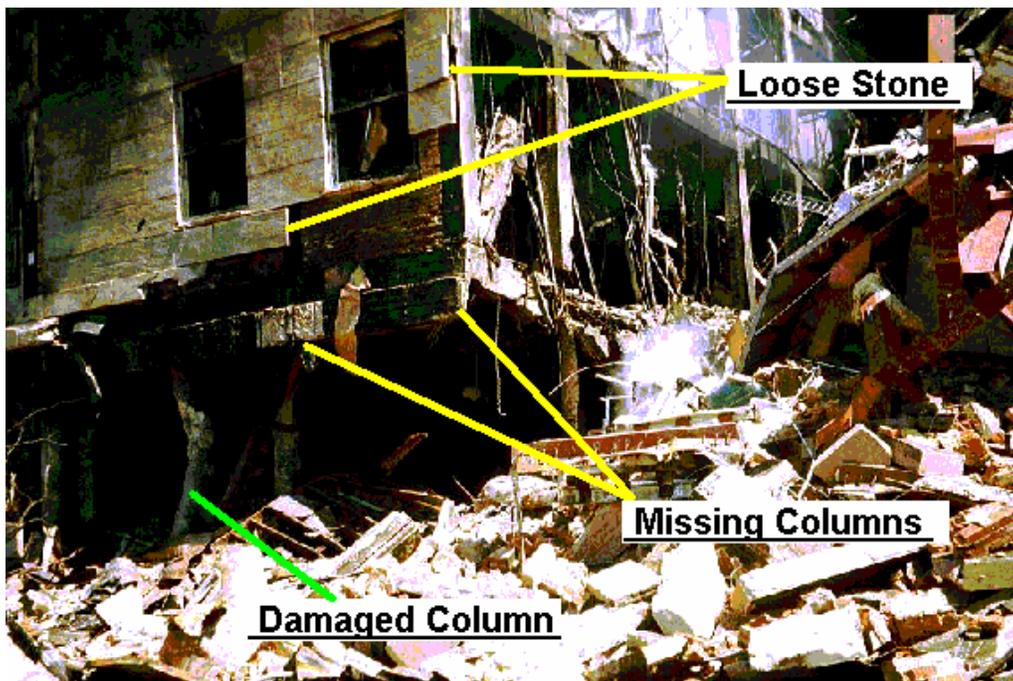
The portion of the structure to the north of the collapse zone had significant column damage and appeared very unstable. Two columns were missing and a third had been severely damaged. This meant that the corner was now a cantilever spanning 3 column bays (approximately 80 feet) and it was not known how long it would hold up before collapsing. Figure 9 shows the missing columns adjacent to the collapse area. This photograph was taken at approximately 3:00 p.m. on September 11th.

Figure 9. Missing Columns. The corner of the structure adjacent to the collapse was missing two columns and one was severely damaged. The section cantilevered approximately 80 feet.

The Structural Specialists on site agreed that the most critical area in need of shoring was the exterior column line, just to the north of the collapse zone. The plan for this area was to construct two nine point crib shores and a solid crib shore to support the vertical loads of the four levels above the damaged area. Figure 16 shows the shoring operations underway in the early morning hours of September 12th.

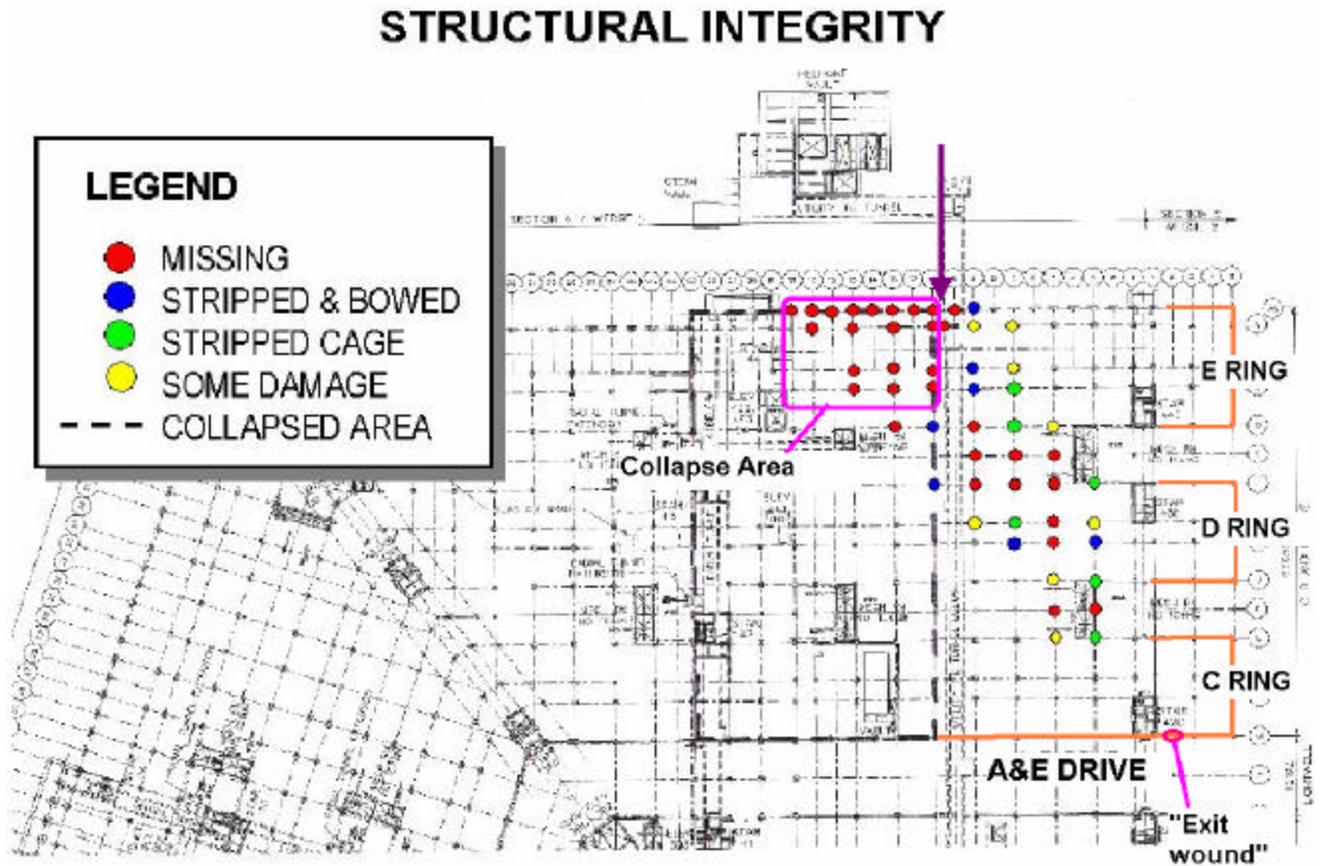
During the week the FEMA Task Forces were on site, the Structural Specialist devoted a good deal of time to thoroughly mapping the damage. Figure 10 was created by the Structural Specialists using plans provided by the Pentagon Renovation contractors. The damage mapped on the plan reveals the angle of entry of the plane and its path through the outer three rings of the building.

Figure 10. Structural Integrity Plan. Indicates missing and damaged columns. (Tills, 2001)

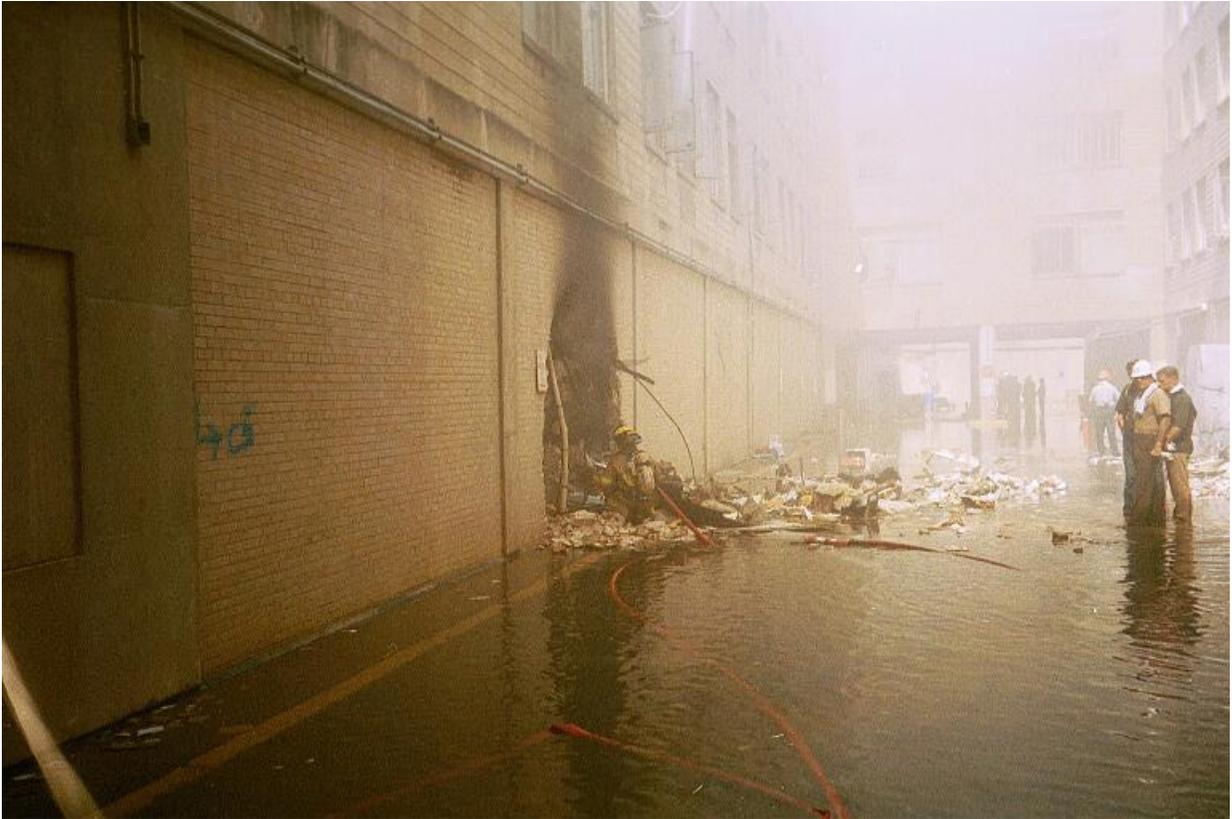
Figure 11 is a photograph taken in A&E drive showing a 9 foot diameter "exit wound" where the plane debris exited the C ring. There were very few identifiable plane parts in the wreckage. Most of the plane disintegrated from the intense heat of the fireball. Other than some fire and smoke damage, there was a relatively small amount of damage in the A and B rings.

Figure11. A&E Drive. The plane exited through C ring and left a pile of debris. The water is from the fire fighting activities. Very few traces of the airplane remained intact.

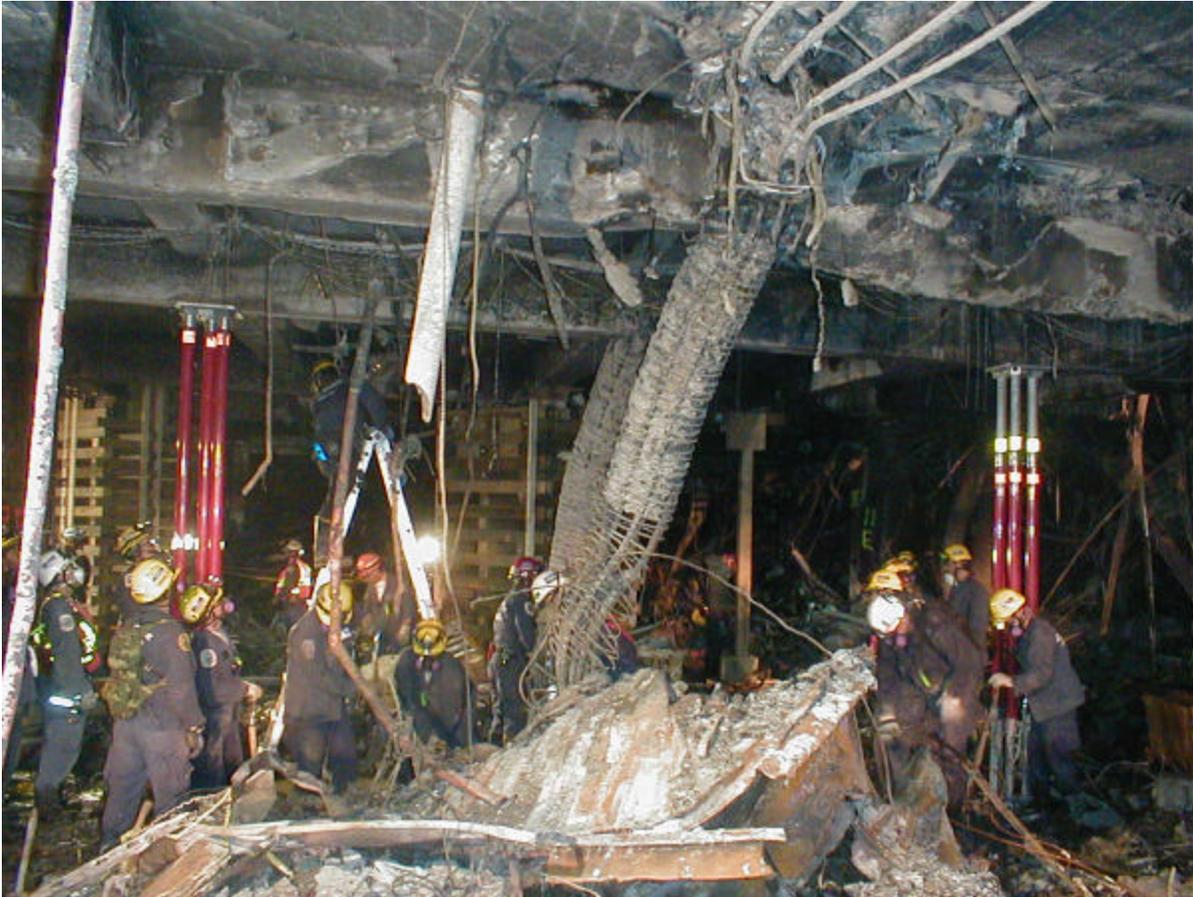
Internal structural damage in Rings C, D and E was significant. Concrete columns were blown apart and twisted into unrecognizable pieces of rubble. The spiral reinforcing steel in the columns had an eerie skeletal appearance. Several beams were missing and holes were blown up through the second floor. Figure 12 is a good example of the internal damage to the concrete structure. Additional pictures of the structural damage are included in the appendix.

Figure 12. Internal damage to concrete columns and beams.

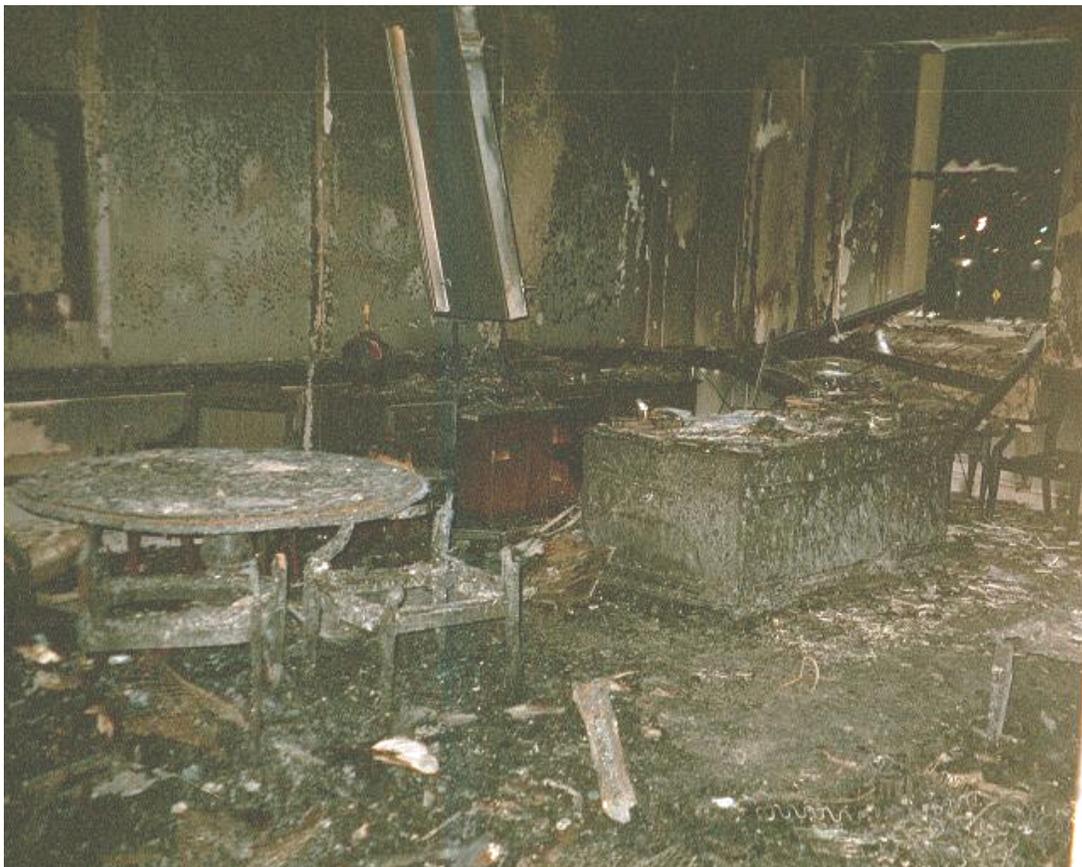
In addition to reduced casualties, it is believed that the newly installed sprinkler system and force protection reduced the amount of damage that would have likely occurred if the renovation had not been completed. In Wedge 2, where the renovation had not yet started, the amount of damage from fire was significantly greater that the Wedge 1 section. Figures 13 and 14 are a comparison of the damage to offices in the renovated and non-renovated sections.

Figure 13. Office in Wedge 2. No sprinklers

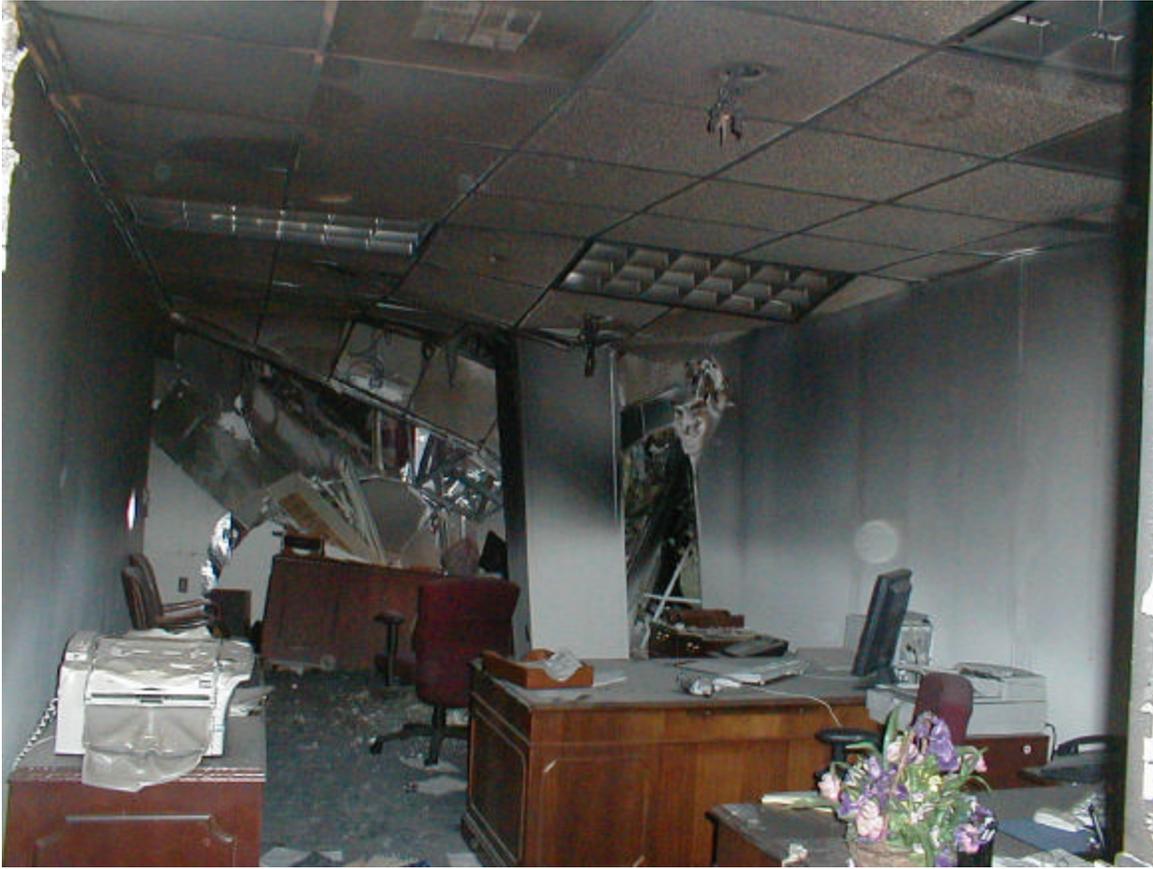
*Figure 14. Office in Wedge 1.
Sprinklers recently installed*

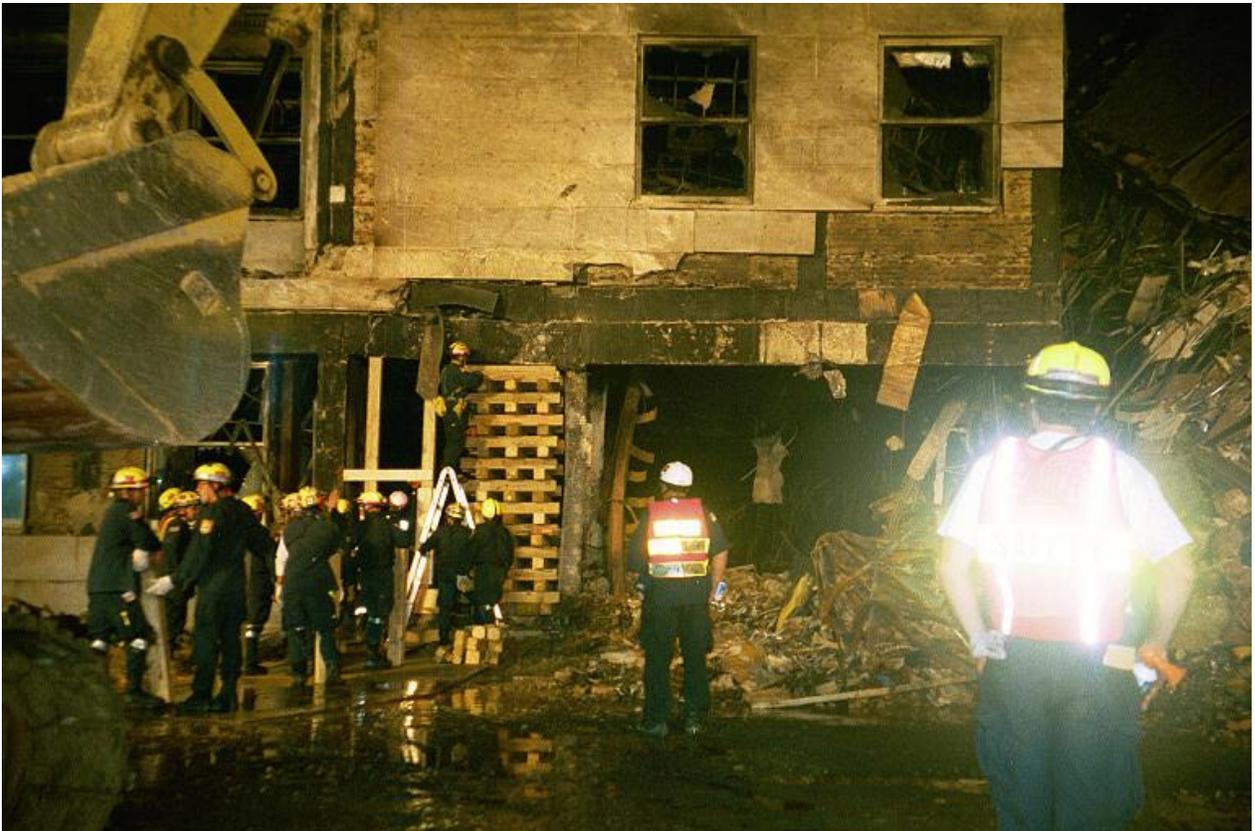
Figure 16. Start of shoring operations. Photo taken as the first crib shore is being completed at approximately 1:00 a.m. the morning of September 12th, 2001.

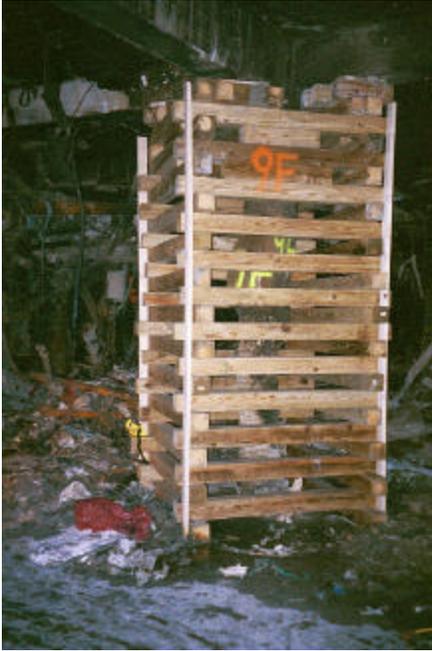
*Figure 18. 4 point crib shore.
Used to support damaged columns still
carrying loads.*

1. **4 Point Crib**: Two by two member layout, yielding four points of contact. Approximate capacity: 60,000 lbs. (30 tons).
2. **9 Point Crib**: Three by three member layout, yielding nine points of contact. Approximate capacity: 136,000 lbs. (68 tons).
3. **Solid Crib**: Eight by eight layout, yielding one large point of contact approximately 48” x 48”. Estimated capacity: 1.1 million lbs. (576 tons). Only one solid crib was used. It was located at the corner of the cantilevered section of the building, immediately north of the collapse zone. The rescue workers decided to build a solid crib at this location because it was thought that it would be more stable in the event debris broke away from the collapsed area and slid into the shoring. (Tills, 2001).

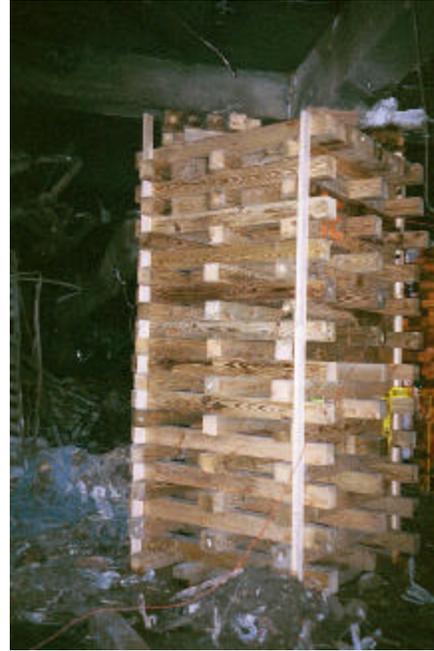
*Figure 19. 9 point crib shore.
Used where columns were severely
damaged or missing completely.*

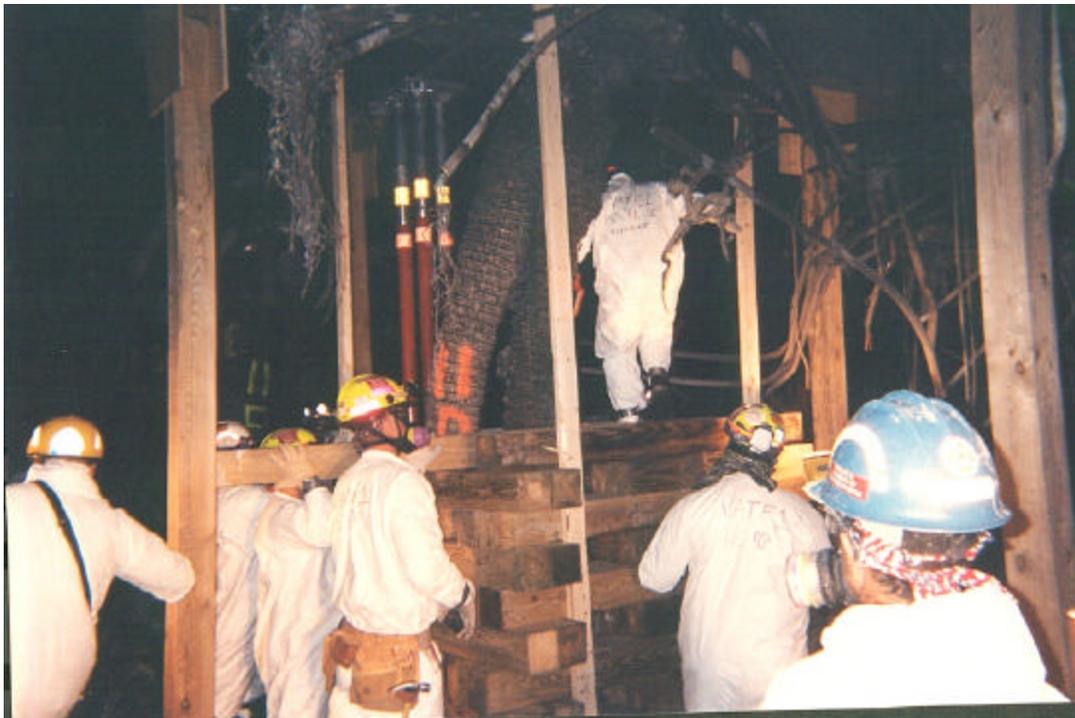
*Figure 20. Crib shore at column 11D. Shoring Squad builds a 4 point crib shore around
damaged column 11D.*

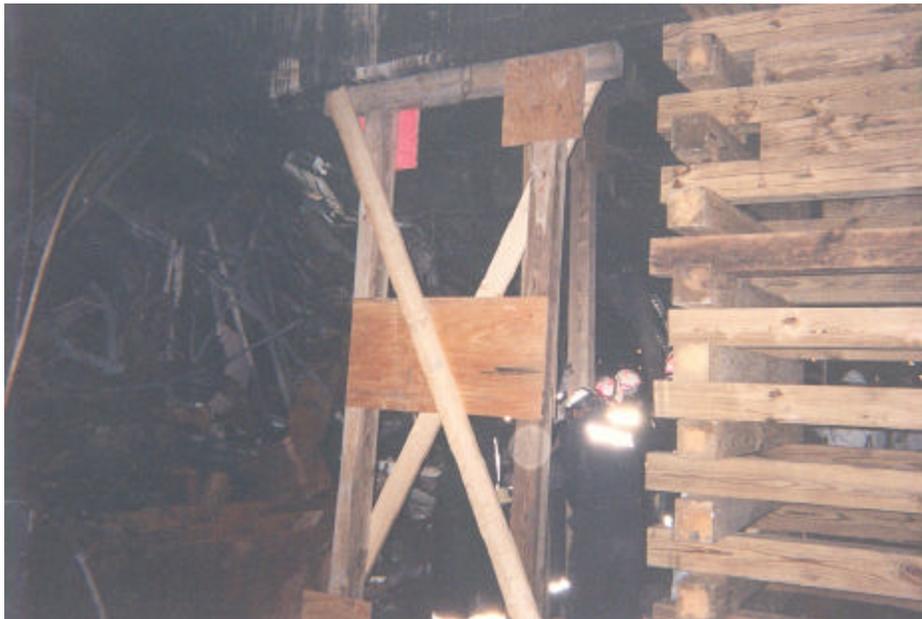
Figure 21. Vertical Shore.

This vertical shore is supporting a beam which allowed the shoring squads to work with reduced risk while building the adjacent crib shore.

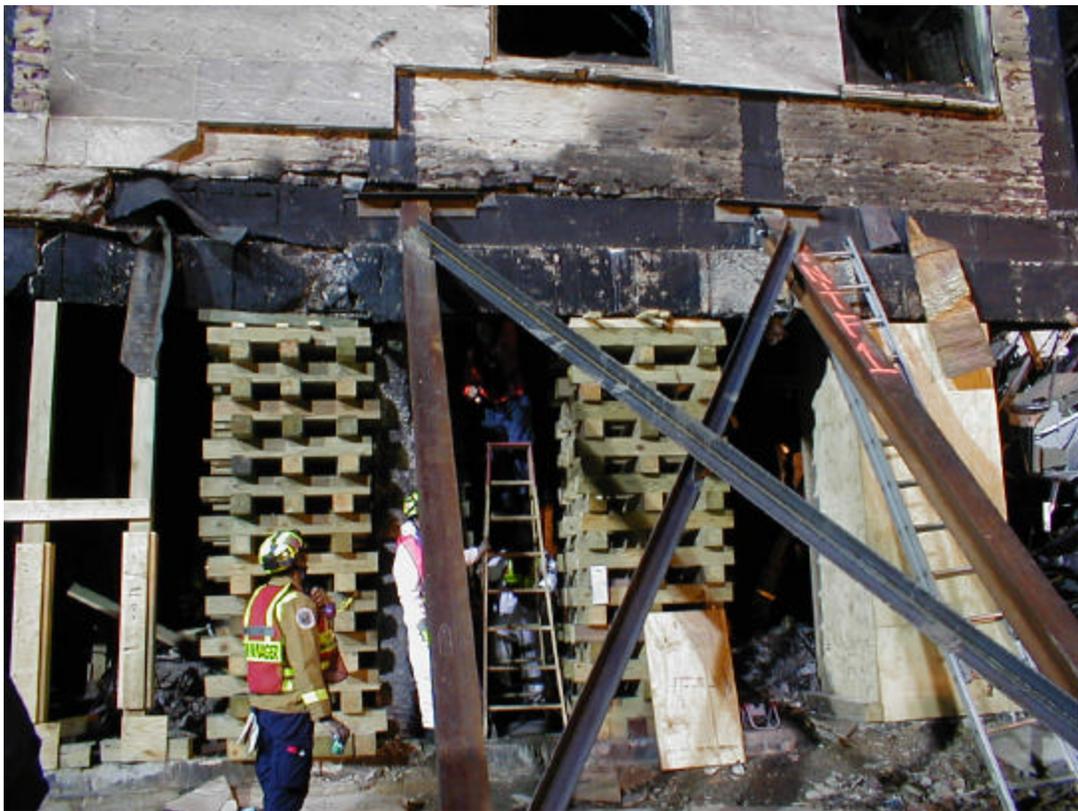
On Thursday, September 13th, the crib shore shims along the exterior wall were over tightened which caused the concrete beam to shift slightly. The Structural Specialists decided that it would be prudent to add a raker shore on the cantilevered section to reduce the possibility of the building wall shifting laterally and possibly collapsing.

Figure 23. Raker Shore for lateral support. Notice the 3 crib shores and 2 vertical post shores for vertical support. The shims at the top of the crib shore were over-tightened causing the concrete beam to shift slightly. VA-TF1 Structural Specialist section leader, Dean Tills, is standing to the left of the raker shore.

At the request of the IST, the contractor on site obtained some steel sections (W6 x 25 and W8 x 24) and some miscellaneous plate sections. The US&R Heavy Rigging Specialists and shoring squads completed the fabrication and installation of the raker shore. This raker shore was approximately 14 feet high with a raker angle of about 45 degrees. Adhesive anchors were used for securing the top of the rake to the concrete (Tills, 2001). Figure 23 is a photograph of the raker shore installed. After the raker was installed, no significant lateral movement was observed during the deployment.
