A Review of the Temporary Shoring Used to Stabilize the Pentagon After the Terrorist Attacks of September 11th, 2001

A Final Scholarly Paper

Leo J. Titus, Jr., P.E.

May 3, 2002

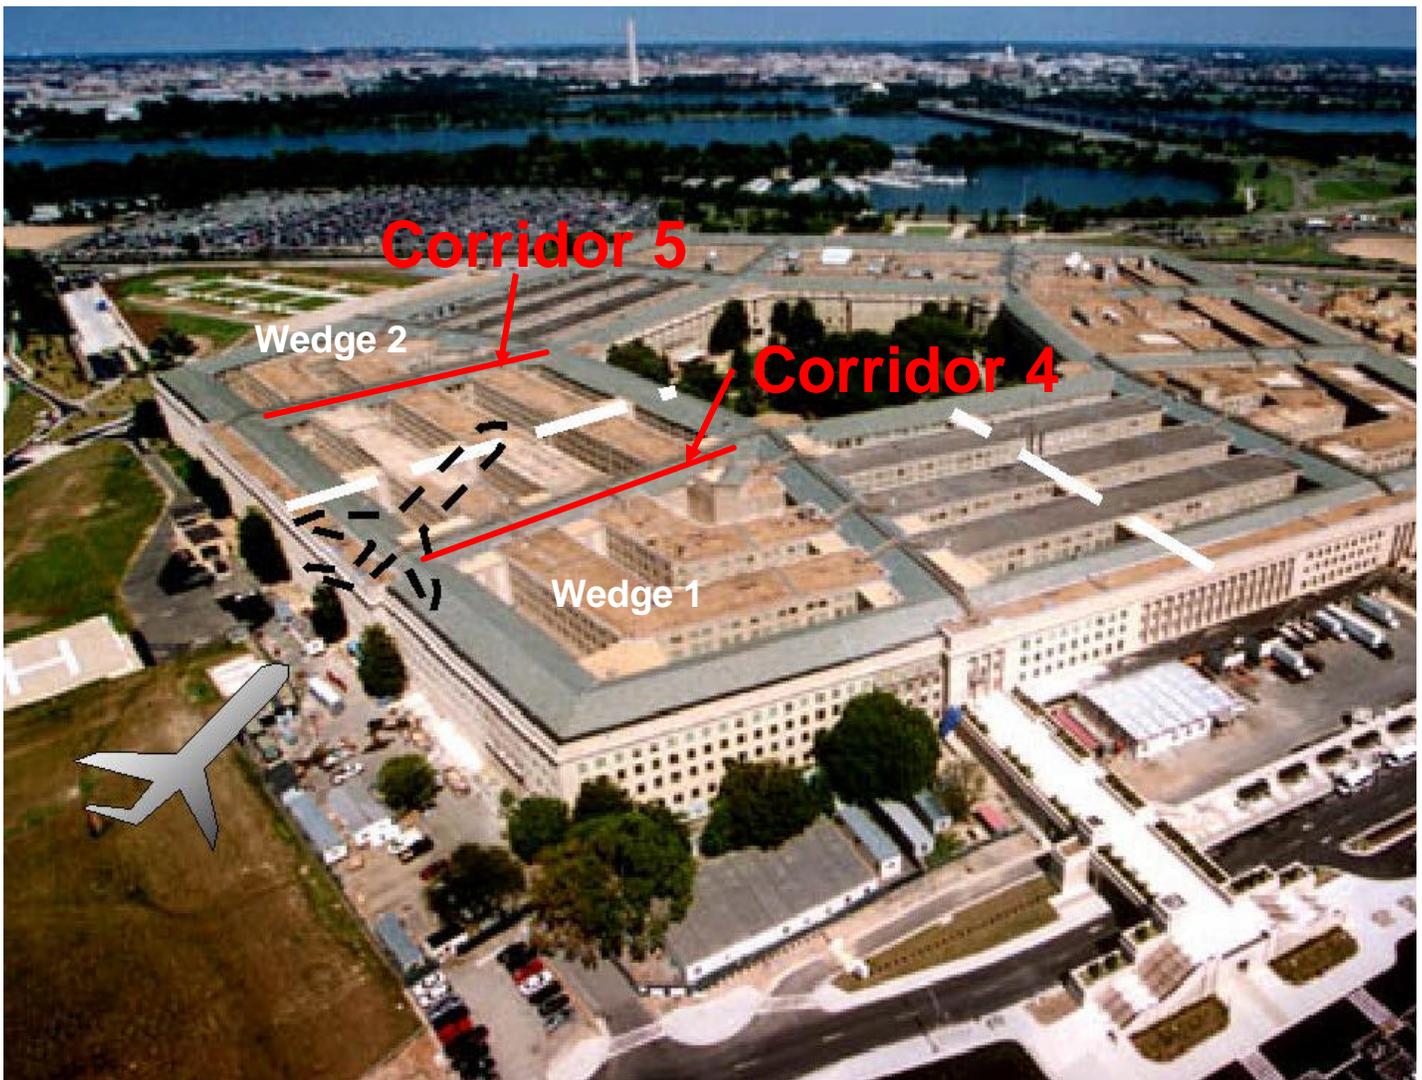
The Pentagon is divided into five wedges. The area of impact was near the division of Wedge 1 and Wedge 2. The section known as Wedge 1 had been under renovation and was scheduled for final completion on Wednesday, September 12th, 2001. The plane reportedly was flying very low and struck the building at the first and second story levels. Figure 4 shows the approximate point of impact between Wedges 1 and 2.

Figure 4. Approximate location and angle of impact and its relationship to Wedge 1 and Wedge 2 (Tills, 2001)

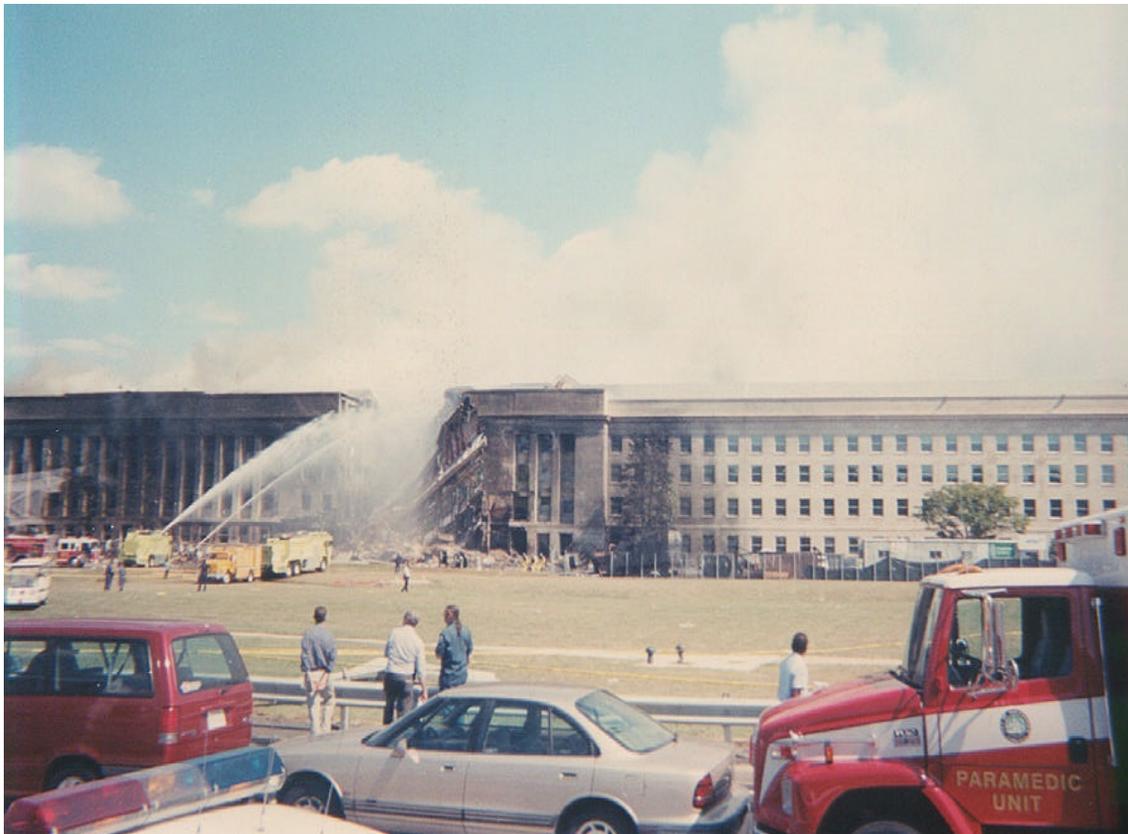
Two buses were chartered and the Task Force, along with its truck loads of equipment were escorted by police to the Pentagon. The entire team and the convoy of supplies arrived at the Pentagon at approximately 1:00 p.m., less than three and a half hours after the impact. Figure 5 is a photograph taken from one of the Task Force buses at approximately 1:00 as they first arrived on site. As Figure 5 shows, the Arlington County Fire Department was still fighting the fire when VA-TF1 arrived at the scene.

*Figure 5. 1:00 p.m. September 11th, 2001.
Photo taken by Leo Titus from one of the VA-TF1 buses.*

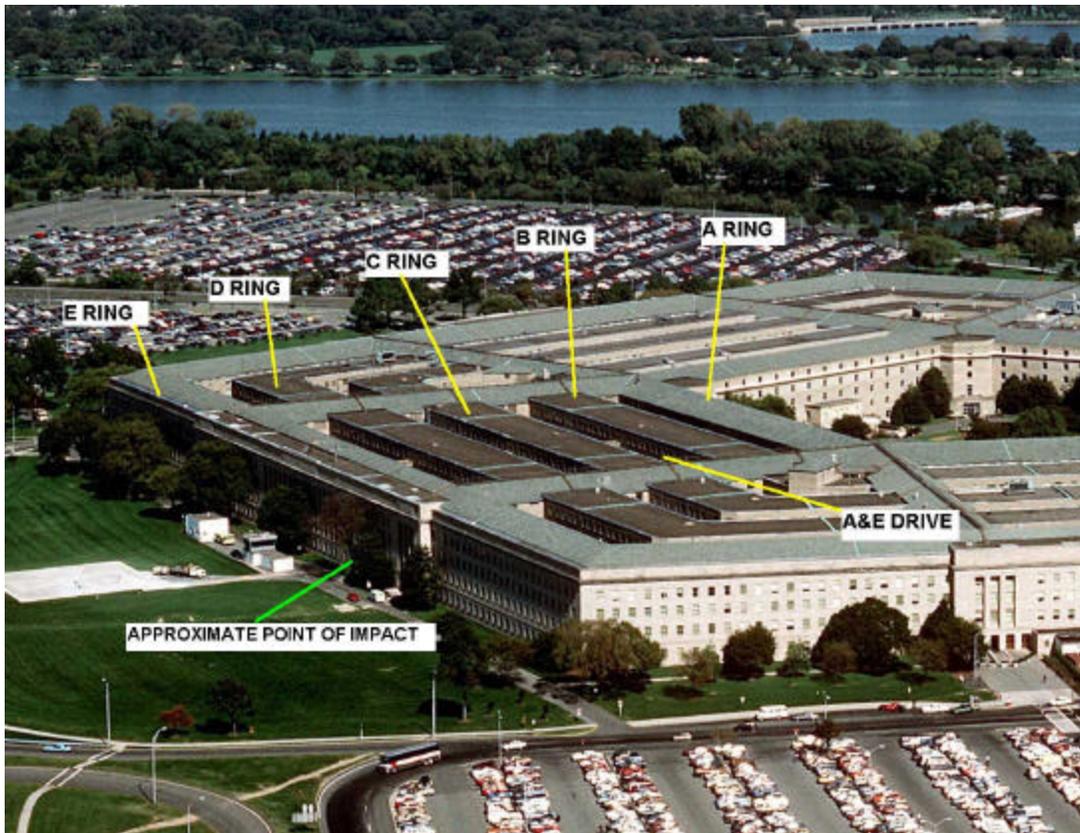
In order to have a better understanding of the damage caused by the attack, it is necessary to review the layout of the Pentagon structure. In addition to the five wedges previously discussed (Wedges 1 through 5), the Pentagon is comprised of five rings (rings A through E). The “A” ring is the innermost ring, and going outward, B, C, D with E being the outermost ring. The plane entered E ring at an angle and the force of the explosion punched through three of the five rings of the Pentagon. A nine foot diameter exit hole was created in the wall of C ring and the remainder of the debris from the impact ended up in the alley between C ring and B ring known as A & E Drive. Figure 8 identifies the rings of the Pentagon and the approximate point of impact.

Figure 8. Identification of the five Pentagon rings and the approximate point of impact.

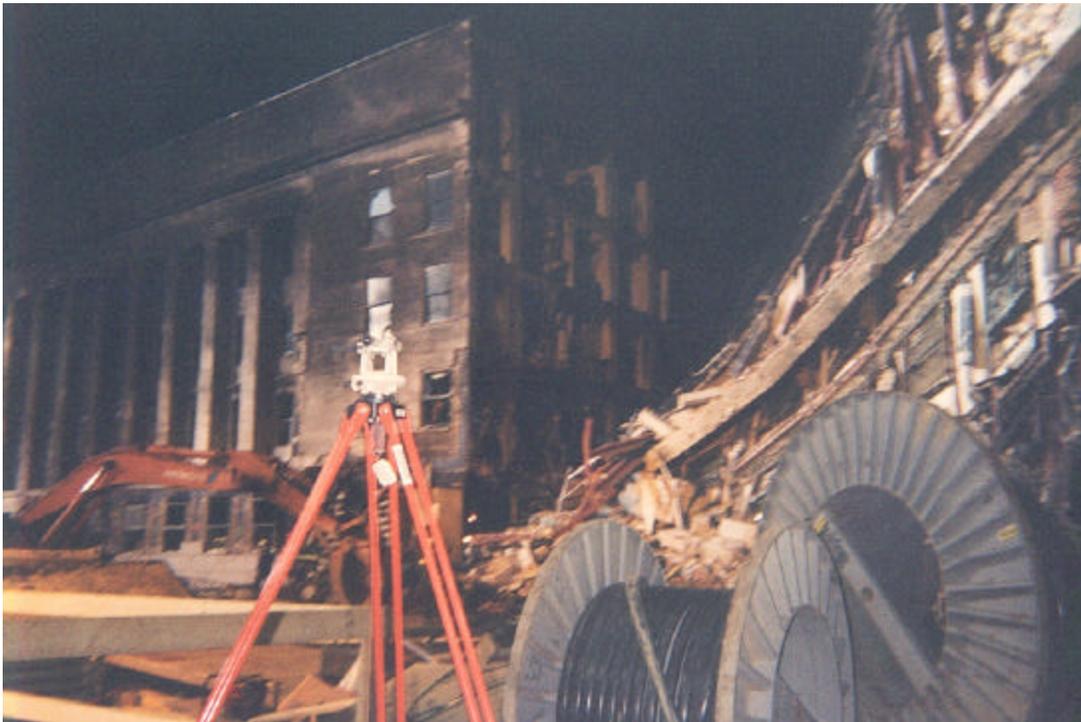
Movement of the building or large pieces of debris being monitored with the transits was recorded at 15 minute intervals. In the event significant movement was observed, the Operations and Safety Managers were notified and decisions would be made on whether or not to evacuate the shoring teams. There was some minor movement observed daily believed to be associated with fluctuations in temperature. Other than that, there was relatively little movement of the structure recorded during the shoring operations. However, it was reported that the building began to show some significant movements several weeks after the shoring was completed and just prior to the demolition started to kick off the reconstruction phase.

*Figure 15. Transit monitoring station.
Transits were set up to monitor several points on the building
during the shoring operations.*

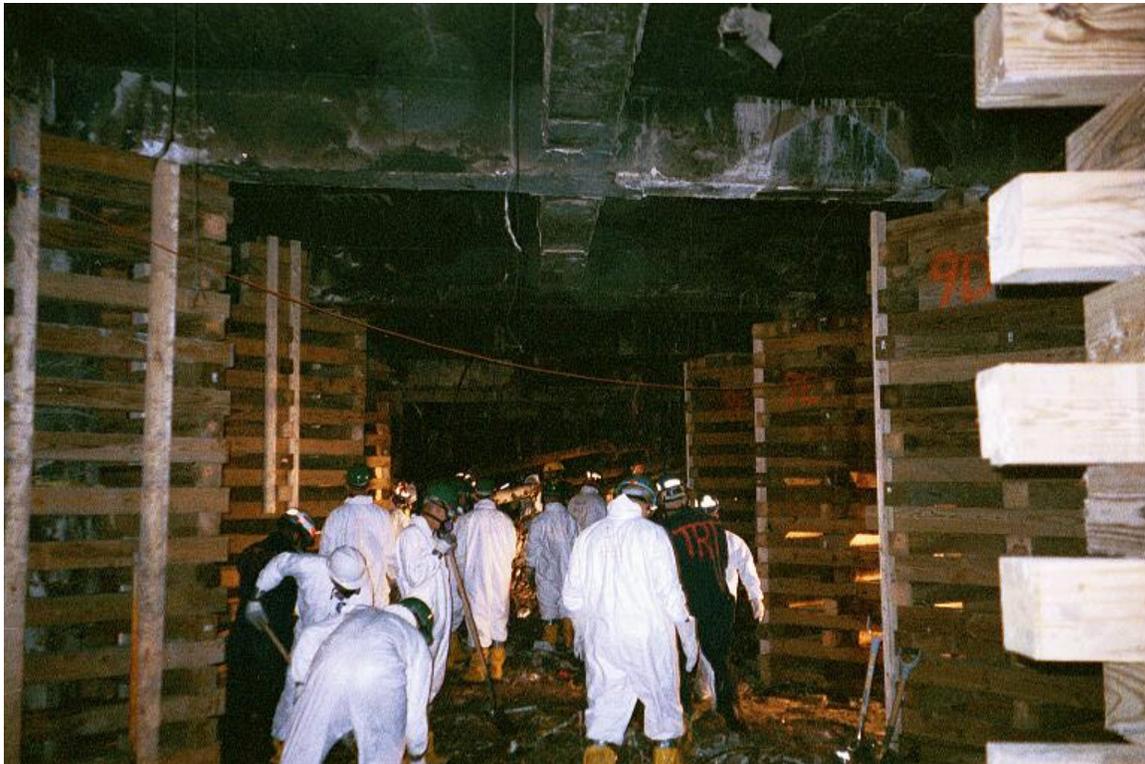
*Figure 24.
Miscellaneous debris is cleaned up in an area where crib shores have been completed.*

By the end of the deployment, 42 columns required shoring on the first floor using 49 box crib shores. Thirty-five beams were shored on the first floor using Tshores and vertical post shores. On the second floor, six columns were shored with box cribs and five beams were shored with vertical post shores. No shoring was required above the second floor (Stanton, 2001). Other than some minor cuts, bruises and sore feet there were no serious injuries during the operation.
